ATC Report No. R-92100/9CR-61

THE EFFECT OF ENVIRONMENT ON THE MECHANICAL BEHAVIOR OF AS/3501-6 GRAPHITE/EPOXY MATERIAL PHASE II

T. HO

Vought Corporation Advanced Technology Center
Dallas, Texas 75266

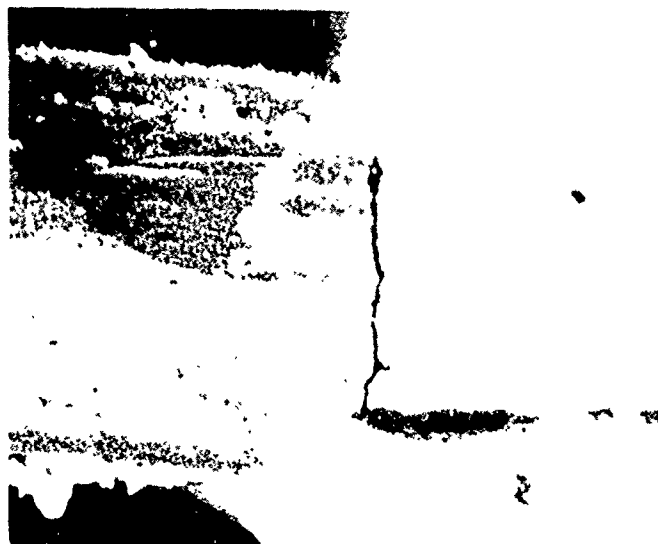
a. POROSITY THAT INITIATED GAGE FAILURE OF SPECIMEN 90-A9-1 TESTED AT 170°F/50% R.H. (16X)

b. POROSITY THAT INITIATED EDGE FAILURE OF SPECIMEN 90-A11-4 TESTED AT 132°F/95% R.H. (16X)

FIGURE 38. POROSITY THAT INVOLVED THE FATIGUE FAILURE OF 90- SPECIMEN.
